URGENT MEDICAL DEVICE CORRECTION

MAQUET CARDIOSAVE hybrid and MAQUET CARDIOSAVE rescue

Product Code/Part Number:	0998-XX-0800-XX
Distributed Affected Lot Number:	All
Distribution Dates:	Since March 6, 2012

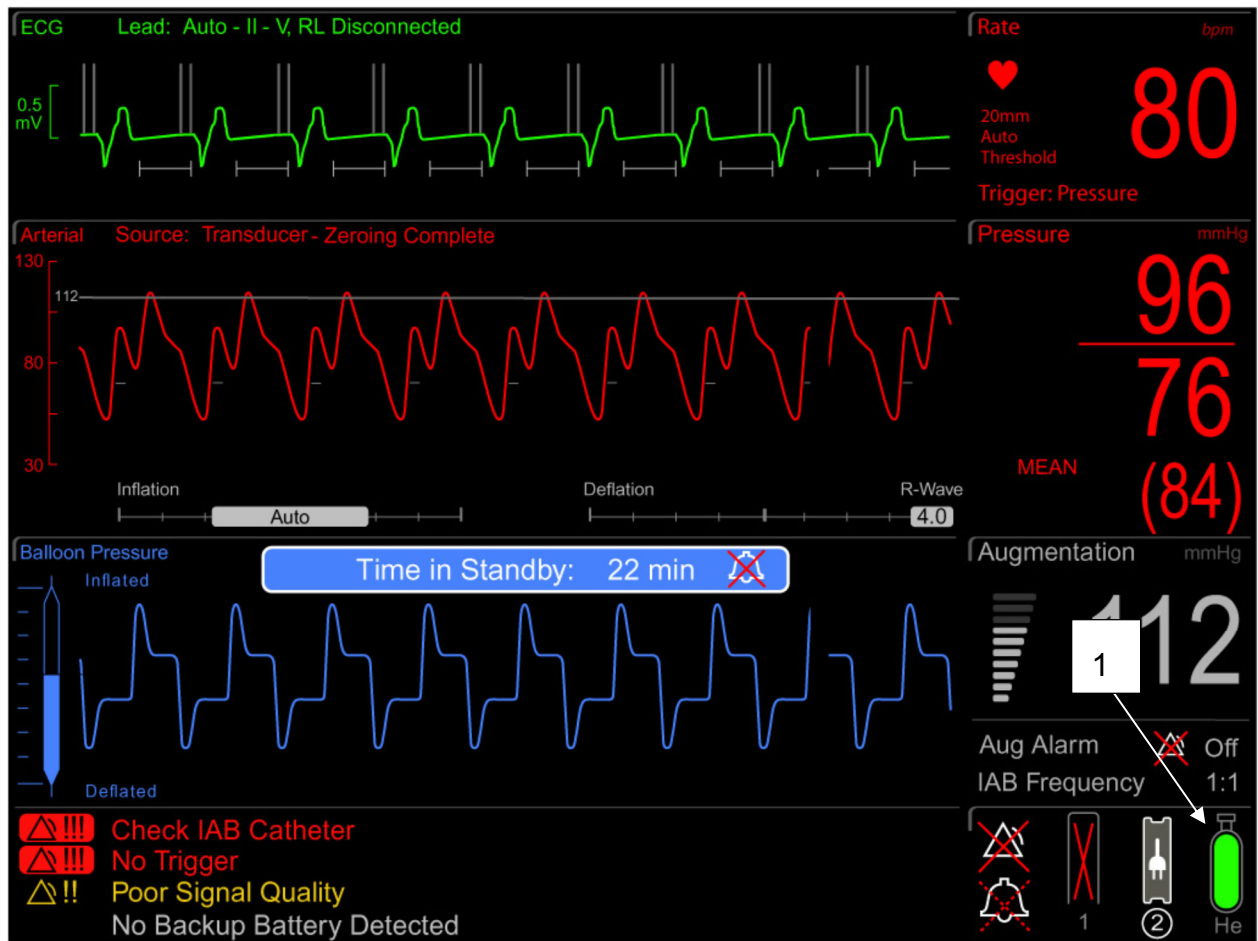
Figure 1 – Monitor Display (1 – Helium Indicator)

During Electromagnetic Compatibility (EMC) testing at an external lab, Getinge personnel determined that in the presence of some radiated RF disturbances, the Helium Indicator on the Cardiosave IABP (refer to Figure 1) would intermittently over-report the remaining Helium Capacity. Once the disturbance was removed the Helium indicator always fully recovered within 10 seconds to display the proper level without any over-reporting.

Getinge’s investigation revealed that the over-reporting of Helium Capacity would intermittently occur at frequency ranges between 80 MHz – 1 GHz. Potential sources of interference include: radio communication, cell phone, Wi Fi, RFID equipment and equipment that does not meet current electromagnetic compatibility standards.

Datascope/Getinge is developing a hardware correction to address this issue. A Datascope/Getinge service representative will contact you to schedule the installation of the correction when available. This work will be done at no cost to your facility.

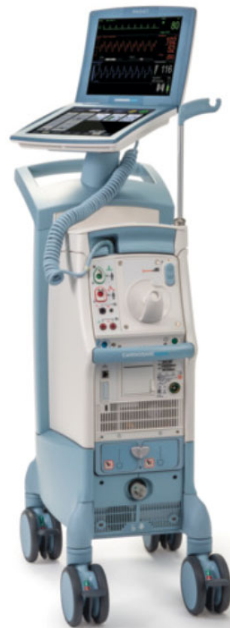
Figure 3: Cardiosave in Hybrid Configuration

Unexpected shutdown can only happen while in Hybrid Configuration (Figure 3) when all four of the below conditions are met:

1. IABP is running on AC power and charging a single battery in voltage charging mode. Voltage charging mode occurs during the last 15-20 minutes of the full charging cycle, when the 5th and final LED charge indicator on the battery pack is flashing.
2. The other battery bay is empty, i.e. no battery is inserted into the second battery bay.
3. The battery is ejected while a system signal erroneously reports the AC power supply is low, this will only happen intermittently when the first two conditions are met.
4. Battery is ejected when all above conditions are met.

To ensure that the Cardiosave Hybrid is not susceptible to the shutdown during the removal of a battery, users should not eject a battery when:

- There is a singular battery in either battery charging bay and unused battery bay is empty.
- The battery is charging on AC power (indicated by a flashing LED on the battery pack).

Additionally, the user can prevent the issue by ensuring that a battery is inserted into each of the two battery bays. Should a charging battery be ejected inadvertently, the unit will automatically switch over to the second battery, thus preventing system shutdown.

Furthermore, Datascope/Getinge is developing a software correction to address this issue. A Datascope/Getinge service representative will contact you to schedule the installation of the updated software. This work will be done at no cost to your facility.

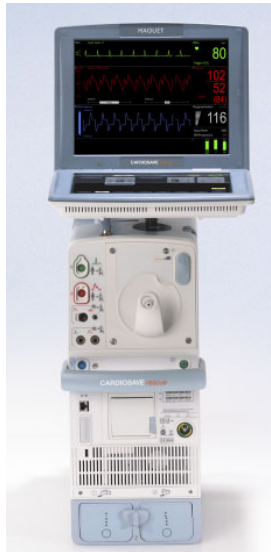
Figure 4: Cardiosave in Transport Configuration

An unexpected shutdown upon battery removal cannot occur for Cardiosave Rescue.
