## URGENT MEDICAL DEVICE CORRECTION Reference Number: 1170852 Vasoview Hemopro 2 Endoscopic Vessel Harvesting System (VH-4000 and VH-4001)

Product Name	Vasoview Hemopro 2 Endoscopic Vessel Harvesting System		
Product Information	Model Number	UDI	Lot Numbers
	VH-4000	00607567700406	All unexpired lots
	VH-4001	00607567700451	All unexpired lots
Manufacturing Dates:	November 1, 2022, to Present		
Distribution Dates:	November 1, 2022, to Present

#### Purpose of the Letter

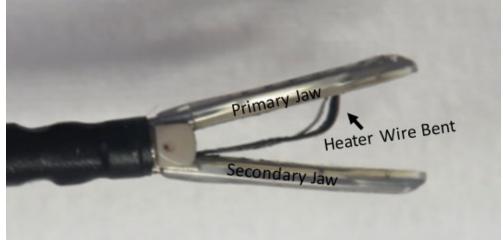
A detached heater wire is defined by disconnection of the heater wire tip from the silicone on the distal end of the harvesting tool jaw, with the proximal end of the heater wire remaining attached to the proximal end of the jaw. It is important to note the heater wire is still attached to the harvesting tool. A bent heater wire is defined by the heater wire bending away from the jaw with no detachment of the distal end. The heater wire can become bent or detached from external mechanical forces or during the initial phase of jaw degradation from user-activated over-delivery of energy. Thermal degradation refers to the process in which the jaw silicone material breaks down or loses its desirable properties due to exposure to high temperatures. This degradation occurs when the heat causes chemical bonds within the silicone polymer to weaken or break, leading to a reduction in the material's structural integrity and flexibility making it more brittle and prone to cracking or tearing.

MCV/Getinge has confirmed 254 complaints between August 1, 2022, and July 31, 2024, related to the bent or detached heater wire. There have been four (4) serious injuries related to this issue. Three (3) of the four (4) serious injuries required an additional incision during the procedure, and one (1) had a procedural delay due to a Pedicle Hematoma with minimal tearing. There were no reports of life-threatening or permanent injury.

Figure 4: Example of a device experiencing a bent heater wire.

- 1. Review the IFU information provided in <u>Appendix A</u>, specifically note the following warnings to minimize over-delivery of energy:
  - When inserting or retracting the Harvesting Tool through the Harvesting Cannula, close the Jaws and ensure the Jaw tips are oriented upwards (concave side up) to prevent damage to the Jaws."
  - "Application of energy without tissue between the Jaws of the Harvesting Tool should be kept to minimum in order to maximize Harvesting Tool performance."
  - "When separation of the branch tissue is noticed, open the Jaws and stop application of energy by pushing the Activation Toggle into the forward most position and retract the Harvesting Tool slightly."
    "NOTE: Once material has been transacted, stop application of energy

- 2. Consider the following to mitigate the risks:
  - Inspect the device prior to use for any signs of damage including silicone peeling away from the jaws.

- Check the outer surface of the device for rough surfaces, sharp edges, or unusual protrusions that may be a hazard.
  - Monitor the device during use for silicone peeling away from the jaws.

- Inspect the device after use for missing or damaged parts.
  - If, at any time of use, the user notices missing or damaged parts or peeling of silicone, device use should be terminated, and any fragmented components should be located and removed from the patient.

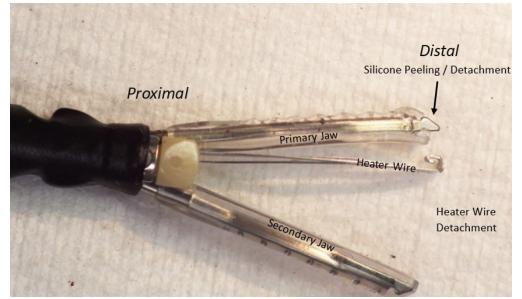
Figure 5: Example of a device experiencing both Heater Wire Detachment and Silicone Peeling/Detachment.

Peeling or detachment of silicone from the Hemopro 2 Harvesting Tool Jaws can result in the Harvesting Tool not functioning as designed and intended. If the Hemopro 2 Harvesting Tool Jaw Heater Wire becomes compromised, bent, or detached from the Jaw during use (as referenced in Figure 5), there is risk of creating hazardous situations that may result in patient harm. The following patient harms, listed in the order of most to least likely to occur, may result if either of the device failures occurs during use of the Vasoview Hemopro 2 EVH System:

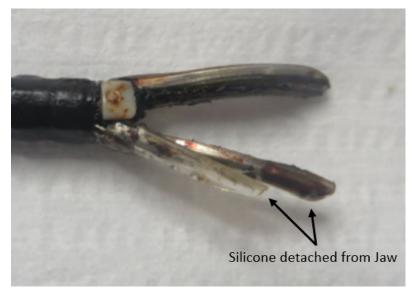
Silicone peeling is defined as silicone that has peeled away from the Harvesting Tool Jaw but remains attached to the Jaw. Silicone detachment is defined as silicone that has peeled away from the Harvesting Tool Jaw(s) and detached from the Jaw assembly. Silicone peeling and detachment can occur when thermal loads on the device are not allowed to adequately cool down between actuations. This can happen when the device is actuated for long periods of time or in quick succession, such as in repeated tissue dissection or application of energy without tissue between the jaws.

MCV/Getinge has confirmed 126 complaints that are related to silicone peeling and/or detaching from the Jaws of the Harvesting Tool during use between November 1, 2022, and October 31, 2024. There have been three (3) serious injuries related to this issue. Two (2) of the three (3) serious injuries required an additional incision during the procedure, and one (1) resulted in a vessel burn. There were no reports of life-threatening or permanent injury.

Figure 6: Example of a device experiencing silicone detachment.
