## URGENT MEDICAL DEVICE CORRECTION Reference Number: 1170852 Vasoview Hemopro 2 Endoscopic Vessel Harvesting System (VH-4000 and VH-4001)

Product Name	Vasoview Hemopro 2 Endoscopic Vessel Harvesting System		
Product Information	Model Number	UDI	Lot Numbers
	VH-4000	00607567700406	All unexpired lots
	VH-4001	00607567700451	All unexpired lots
Manufacturing Dates:	November 1, 2022, to Present		
Distribution Dates:	November 1, 2022, to Present

#### Purpose of the Letter

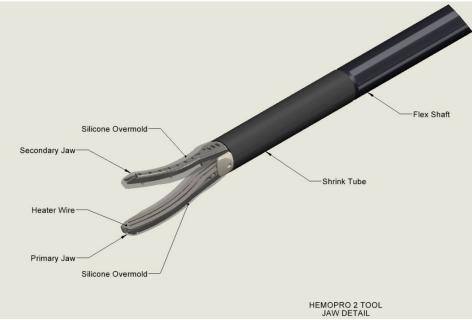
Figure 3: Harvesting Tool

A detached heater wire is defined by disconnection of the heater wire tip from the silicone on the distal end of the harvesting tool jaw, with the proximal end of the heater wire remaining attached to the proximal end of the jaw. It is important to note the heater wire is still attached to the harvesting tool. A bent heater wire is defined by the heater wire bending away from the jaw with no detachment of the distal end. The heater wire can become bent or detached from external mechanical forces or during the initial phase of jaw degradation from user-activated over-delivery of energy. Thermal degradation refers to the process in which the jaw silicone material breaks down or loses its desirable properties due to exposure to high temperatures. This degradation occurs when the heat causes chemical bonds within the silicone polymer to weaken or break, leading to a reduction in the material's structural integrity and flexibility making it more brittle and prone to cracking or tearing.

MCV/Getinge has confirmed 126 complaints that are related to silicone peeling and/or detaching from the Jaws of the Harvesting Tool during use between November 1, 2022, and October 31, 2024. There have been three (3) serious injuries related to this issue. Two (2) of the three (3) serious injuries required an additional incision during the procedure, and one (1) resulted in a vessel burn. There were no reports of life-threatening or permanent injury.

- 2. Consider the following to mitigate the risks:
  - Inspect the device prior to use for any signs of damage including silicone peeling away from the jaws.

- Check the outer surface of the device for rough surfaces, sharp edges, or unusual protrusions that may be a hazard.
  - Monitor the device during use for silicone peeling away from the jaws.

- Inspect the device after use for missing or damaged parts.
  - If, at any time of use, the user notices missing or damaged parts or peeling of silicone, device use should be terminated, and any fragmented components should be located and removed from the patient.
